Case Study #27

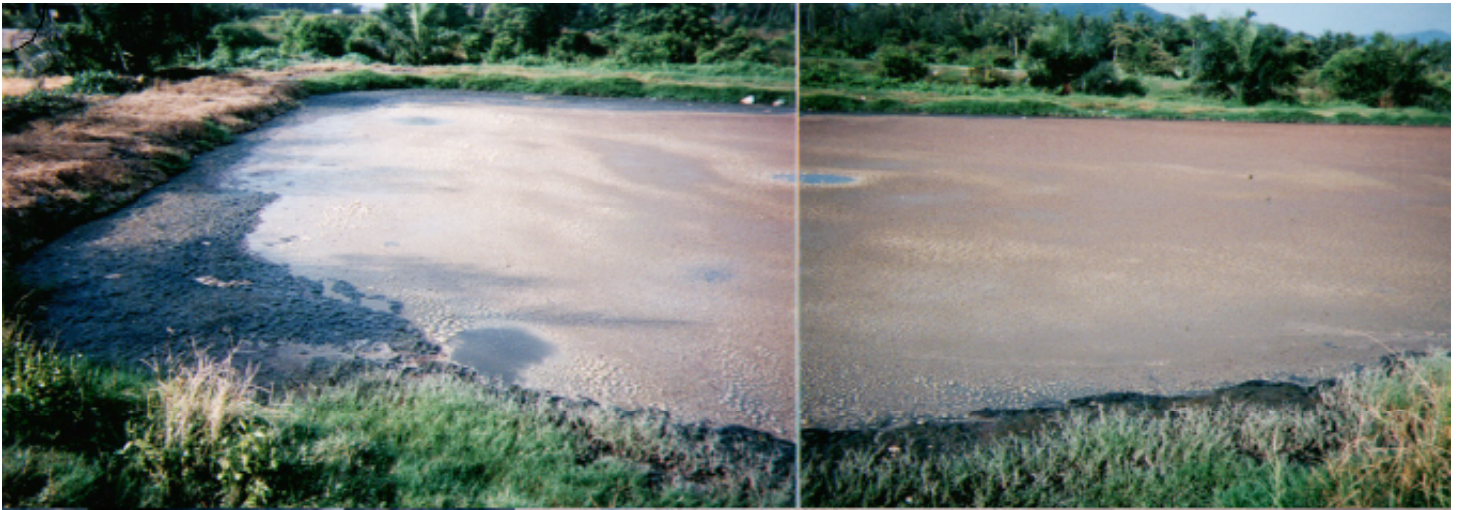
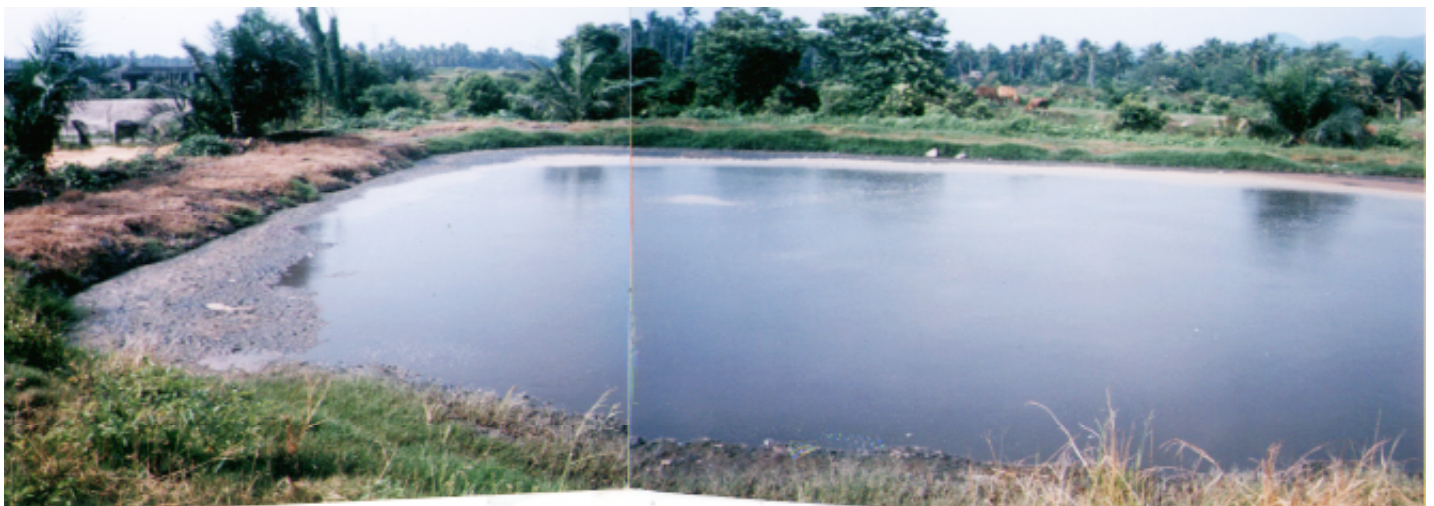
- Client Category:** Palm Oil Manufacturing Plant
- Location:** Penang, Malaysia
- Physical Plant:** A large lagoon measuring 300 feet x 50 feet
- Flow:** 100,000 to 125,000 gallons per day
- Problem:** Lagoon was covered with palm oil grease cap.
- Treatment:** Initial Treatment of 2 drums **Custom FM** sprayed directly onto the surface of the lagoon.
- Regular Treatment of 1 drum of **Custom FM** per month added into the lagoons influent.
- Nutrients - Initially, 55 pounds of recommended nutrients were added every 4 days. Nutrients are monitored and adjusted.
- Results:** Grease cap on the lagoon was almost completely cleared after 15 days of treatment. Client was completely satisfied.
